**Flood Control Project Maintenance
Levee Inspections**
LMA District Cover Sheet
Spring 2018 Levee Inspection Results

California Department of Fish and Game Shea Levee

Levee Inspection Report By Mile - Spring 2018

Waterway	Bank	Unit Miles	Inspection Start/End	Inspector
Unit No. 01 Sacramento River	Left	0.30	04/20/2018 04/20/2018	Bob Duffey

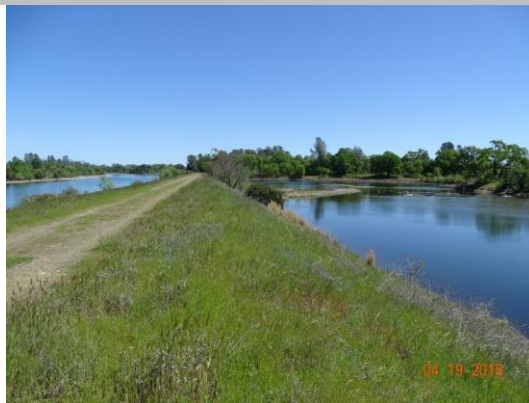
Photo 1 of 2 : SP_2018_NA0018_269_2_20180423_00005.jpg

LM Start	0.00	Rating **	M	Issue No.	2
LM End	0.30	Issue Type +	Ma	Location *	LS
Category	Earthen Levee			GPS Latitude/Longitude	
				Start	End
Item	Vegetation			40.507697 °	40.511210 °
				-122.363683 °	-122.360390 °
DWR ID	DWR_NA0018_01_s_2012_2				
Comment Code					
V2 : Remove the wild growth other than native grasses from the levee slopes.					
Inspector Comment					
California Department of Fish and Wildlife has not completed any maintenance this year.

View of the vegetation along the landside slope.

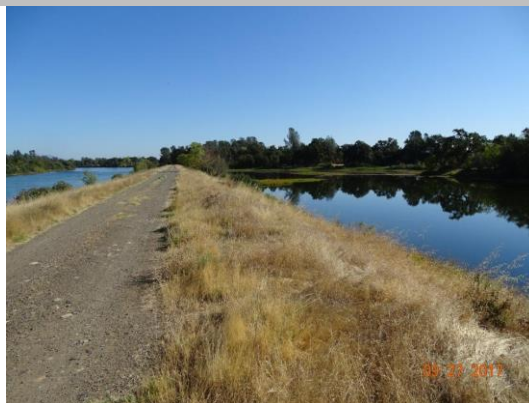
Photo 2 of 2 : SP_2018_NA0018_269_2_20180305_00002.jpg

View of the vegetation along the landside slope.

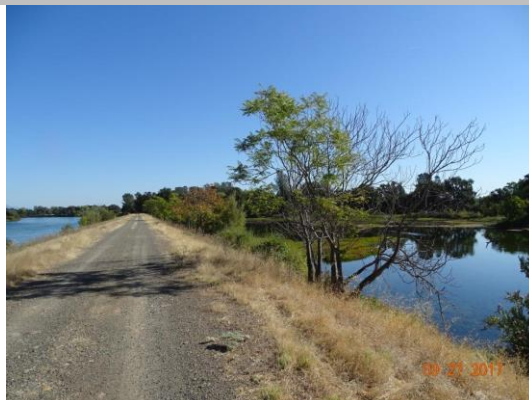
Photo 1 of 1 : SP_2018_NA0018_269_3_20180305_00004.jpg

LM Start	0.00	Rating **	M	Issue No.	3
LM End	0.30	Issue Type +	Ma	Location *	LS
Category	Earthen Levee			GPS Latitude/Longitude	
				Start	End
Item	Trim / Thin Trees			40.507738 °	40.511210 °
				-122.363682 °	-122.360390 °
DWR ID	DWR_NA0018_01_f_2017_3				
Comment Code					
T3 : Trim and thin trees to allow visibility of the ground and room to flood fight.					
Inspector Comment					
Trim and remove trees to allow visibility.

View of the trees along the landside slope.

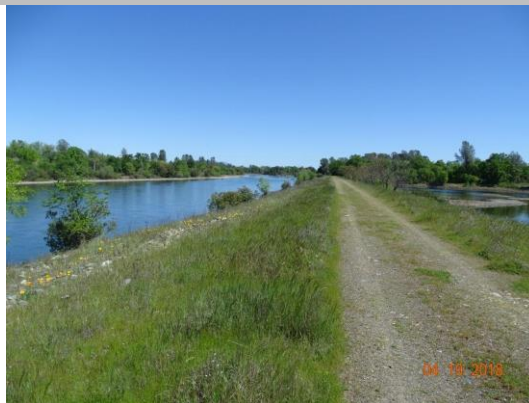
Photo 1 of 2 : SP_2018_NA0018_269_1_20180423_00006.jpg

LM Start	0.00	Rating **	M	Issue No.	1
LM End	0.30	Issue Type +	Ma	Location *	WS
Category	Earthen Levee			GPS Latitude/Longitude	
				Start	End
Item	Vegetation			40.507697 °	40.510670 °
				-122.363683 °	-122.361203 °
DWR ID	DWR_NA0018_01_s_2012_1				
Comment Code					
V2 : Remove the wild growth other than native grasses from the levee slopes.					
Inspector Comment					
Remove the vegetation from the waterside slope.

View of the vegetation along the waterside slope.

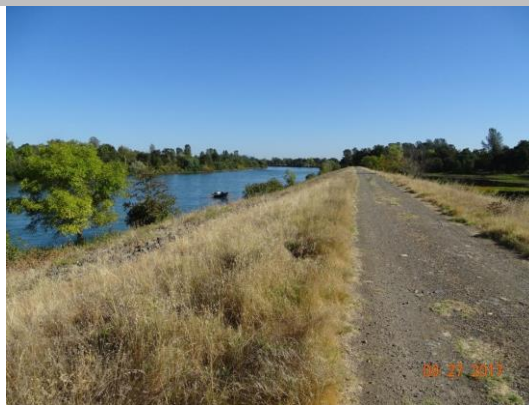
Photo 2 of 2 : SP_2018_NA0018_269_1_20180305_00001.jpg

View of the vegetation along the waterside slope.
